Dune Management at Piha

Review and Proposed Management Plan

Prepared for Auckland Council
Prepared by J Dahm, Eco Nomos Ltd
Version 2 – October 2013

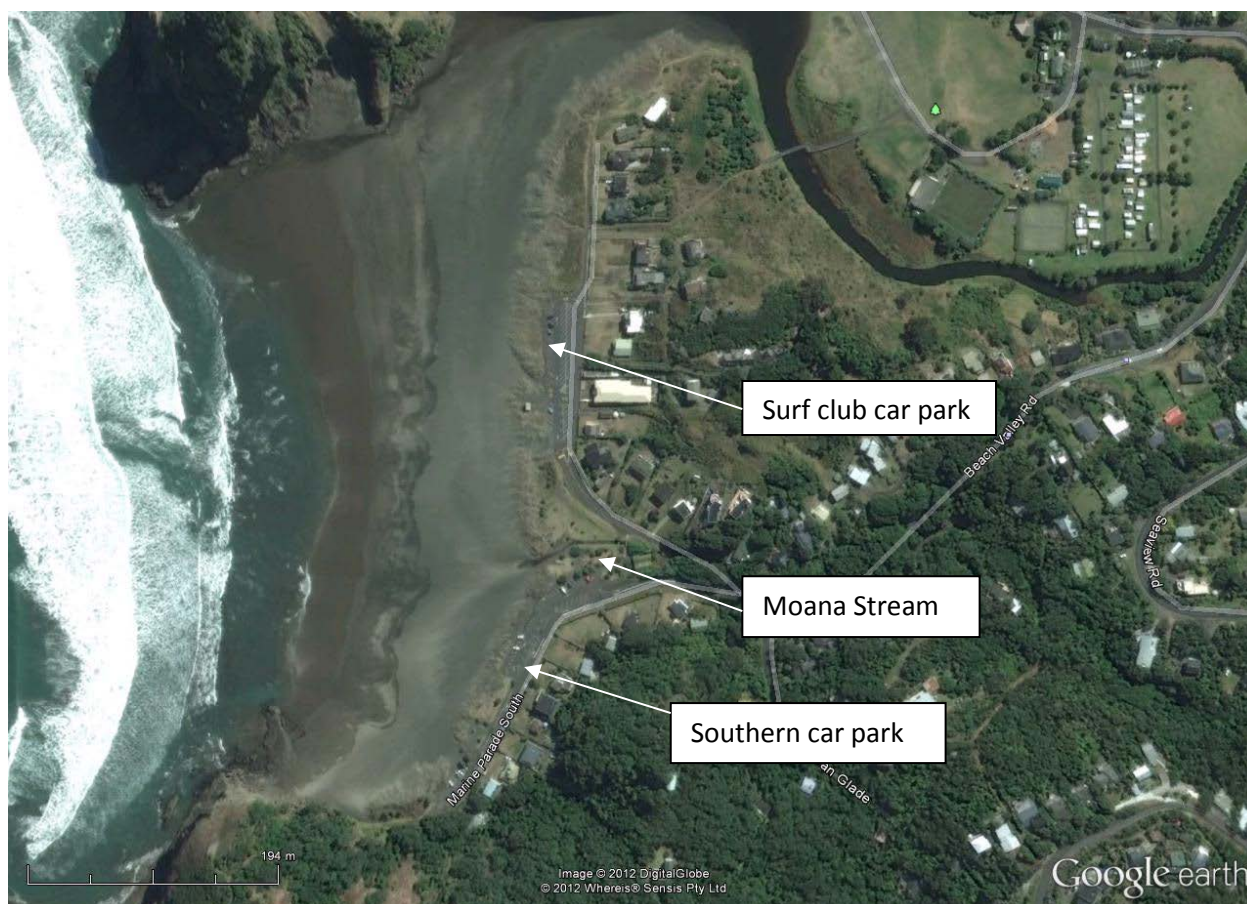
Figure 1: Area of Piha Beach relevant to this review

The study for this report is the area of Piha along Marine Parade South (south of Lion Rock) (Figure 1), one of New Zealand's most iconic beaches and a popular destination for surfing and swimming.

Important community infrastructure (including the Surf Club, car parks, road access and stormwater drainage) and private properties occur directly landward of the dunes (Figure 1). These assets are located within what was originally the active dune system and have only a limited width of dune buffer to seaward (Figure 1). These areas have experienced issues with windblown sand.

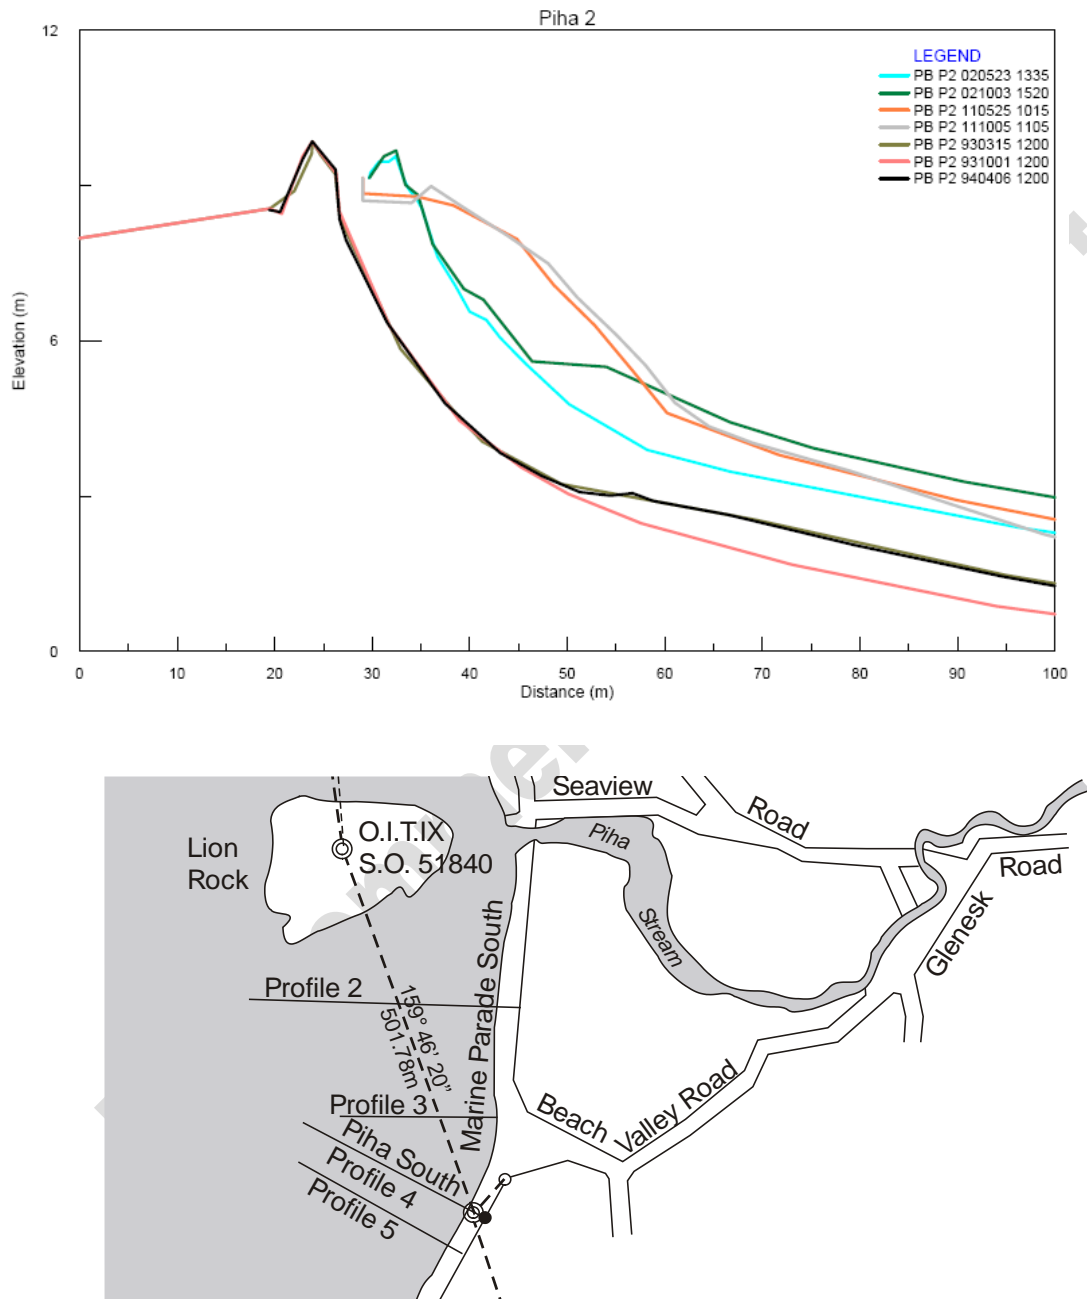
Figure 4: Selected surveys conducted at Auckland Council beach profile site Piha 2 (top) showing progressive shoreline advance over time since surveys commenced in 1993. The most landward profiles are from 1993 and 1994; the mid profiles from 2002 and the most seaward profiles date from May and October 2011. The beach profile monitoring site is located near the surf club as shown in the location map (bottom) – where it is labelled “Profile 2”.

Beach profile monitoring at the southern end of Piha Beach by Auckland Council indicate that this shoreline is continuing to advance seaward in front of the surf club (Figure 4) and the landward end of the southern car park. The shoreline in front of the surf club has in fact grown seaward at an average rate of about 1 m/yr over the period of the beach profile record (Figure 4) – similar to the high rates observed in some periods in central and northern areas of the beach by King et al (2006).

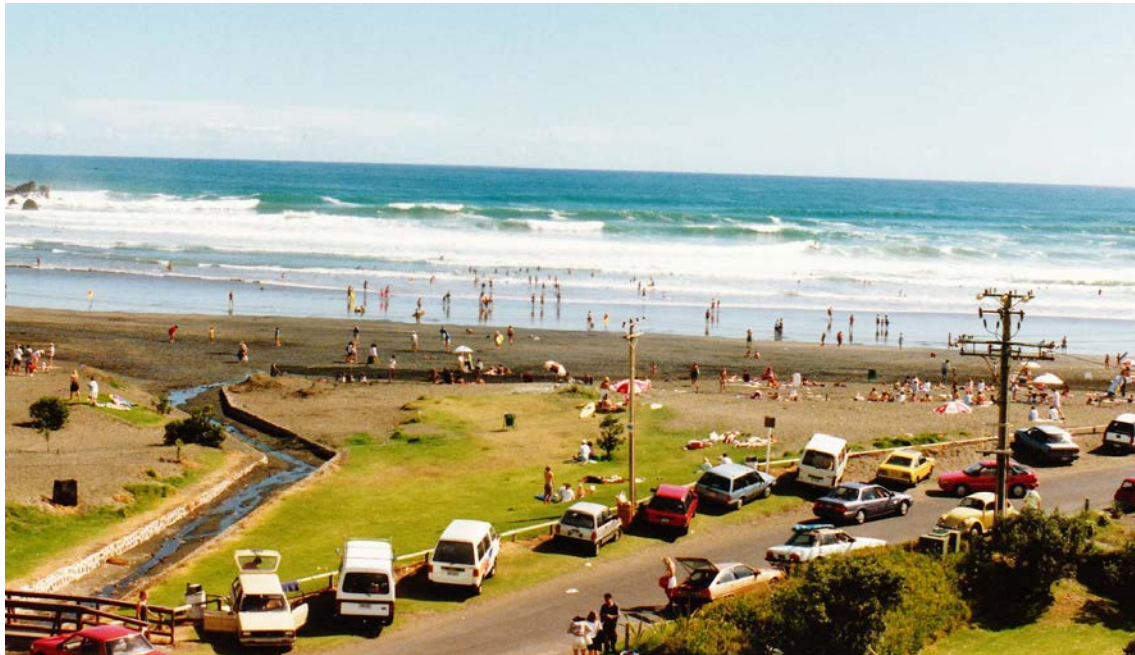
Figure 5: Moana Stream in 31 March 1991 subsequent to training (concrete lining) of stream (1984–5) which eliminated the earlier flared entrance to create a larger grassed amenity area. This photo was taken prior to construction of the along dunes along seaward margin and it can be clearly seen that beach views from the reserve were then quite expansive (Photo supplied by Mr Barry Davis).

The training of the Moana Stream and associated work was unnecessary as made clear in the 1992 Turner decision. There is also no question that the works significantly altered the natural and human use values of the area. It is unlikely however that the infilling and reclamation of the former flared stream entrance played a significant role in the beach advance. Breaking waves transport large volumes of water into the Piha Beach embayment every day and it is the return of this water to the sea that generates the very strong longshore currents and rips. The big swells surging in and out of Moana Stream, while undoubtedly impressive, were only occasional events and would only ever have been a small component of the wave generated circulation in the embayment south of Lion Rock. The works in the Moana Stream entrance are therefore not likely to have significantly affected the volumes of water circulating through the embayment. It is agreed that any impact on this aspect would certainly have been negative (i.e. reduced flows) rather than positive but the effect on the total volumes of water circulating through the embayment would have been very small. The human- built dune shown in Figure 6 would also not have survived if the beach had not already advanced seaward because of the large volumes of sand being moved into Piha Beach from areas further south. In fact, it is probable that a natural dune would have developed over part of the area in response to the beach advance – though a flared stream entrance would have remained in the absence of the stream training works.

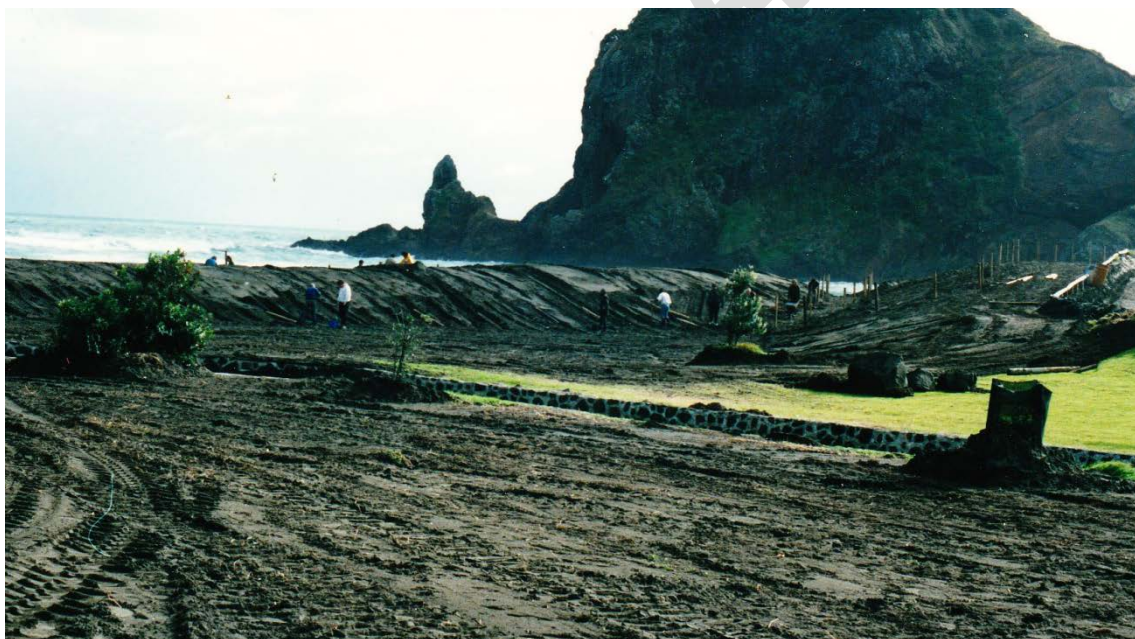
Figure 6: Photograph a few months later (31 May 1991) shortly after human construction of dune across the seaward margin of Moana Stream. This dune diminished views of the beach reserve and may also have impacted on sea views from the adjacent road and some private properties. The dune has however also enhanced amenity by providing a sheltered area that folk can picnic in during the common periods of winds from westerly directions. (Photo supplied by Mr Barry Davis).

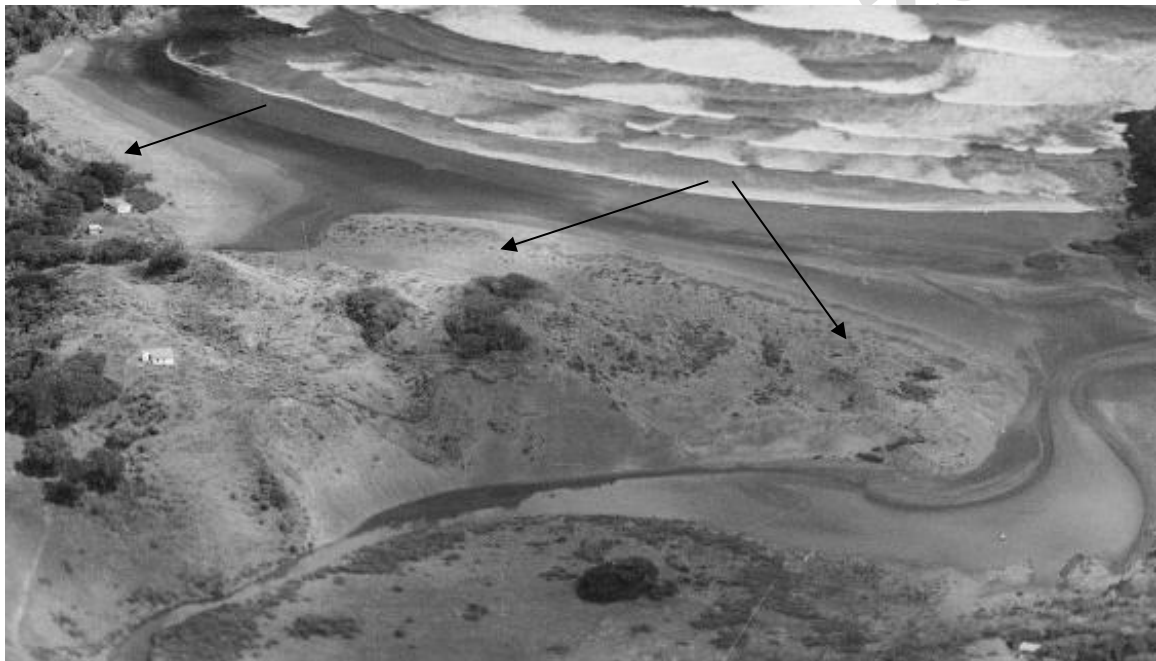
Figure 7: Photograph of Piha Beach dating from the early 1930's showing areas of natural dunes (arrowed) – also evident in earlier photos. (Photograph from Alexander Turnbull Library).

The photos indicate a relatively extensive cover of spinifex over the dune areas and patches of darker vegetation further landward, with little to no evidence of human damage (Figure 7).

The dunes at Piha Beach are often referred to as “artificial dunes”, even within parts of the Piha Coastal Management Plan. However, it is clear from this historic photography that vegetated dunes are natural to this area of Piha – except in the immediate vicinity of the Moana Stream entrance where dune building would have been naturally restricted by stream flow discharging across the upper beach with alongshore migration of the stream channel. The latter are the only artificial (i.e. man-made) dunes. Long-time residents/visitors to Piha recount that the large dune at the extreme south end of the beach (adjacent to the boat launching area) was first constructed by humans – but a dune would have developed in this area naturally as the beach advanced creating an increased width of high tide beach.

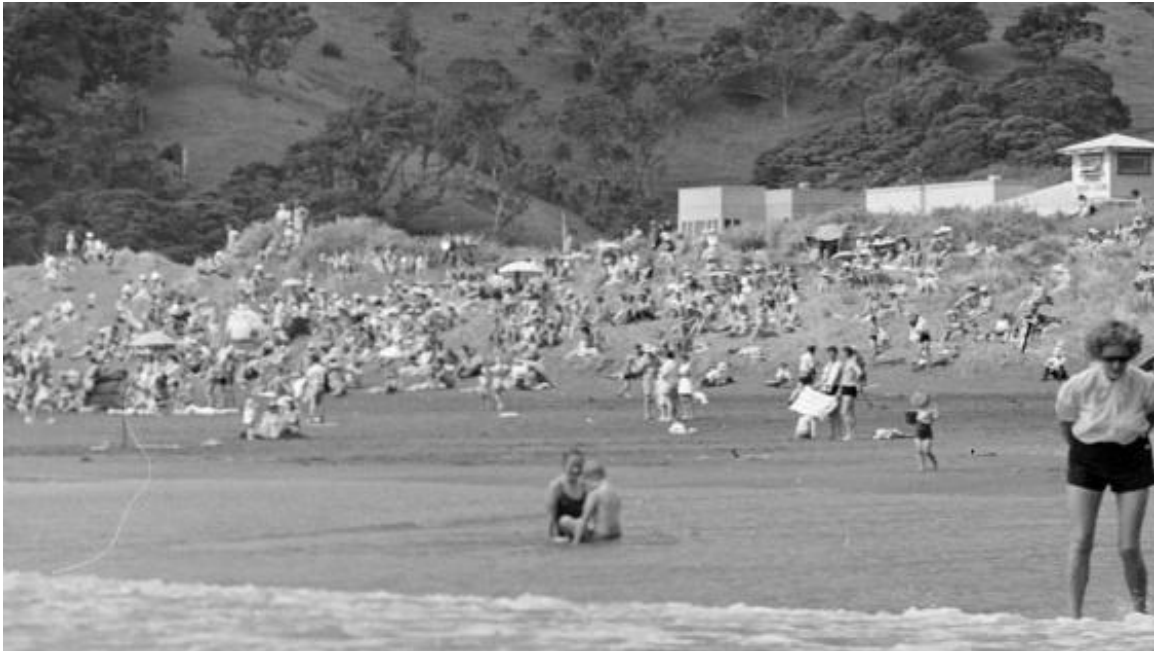
Figure 8: Photograph of area in front of the former surf club. Note people sitting all over the seaward face of the frontal dune, damaging the sensitive native sand trapping vegetation. (Photograph from Alexander Turnbull Library).

the 1940's show poorly managed human use, with intense human pressure on the critical sand trapping vegetation on the seaward dune face (Figure 8)

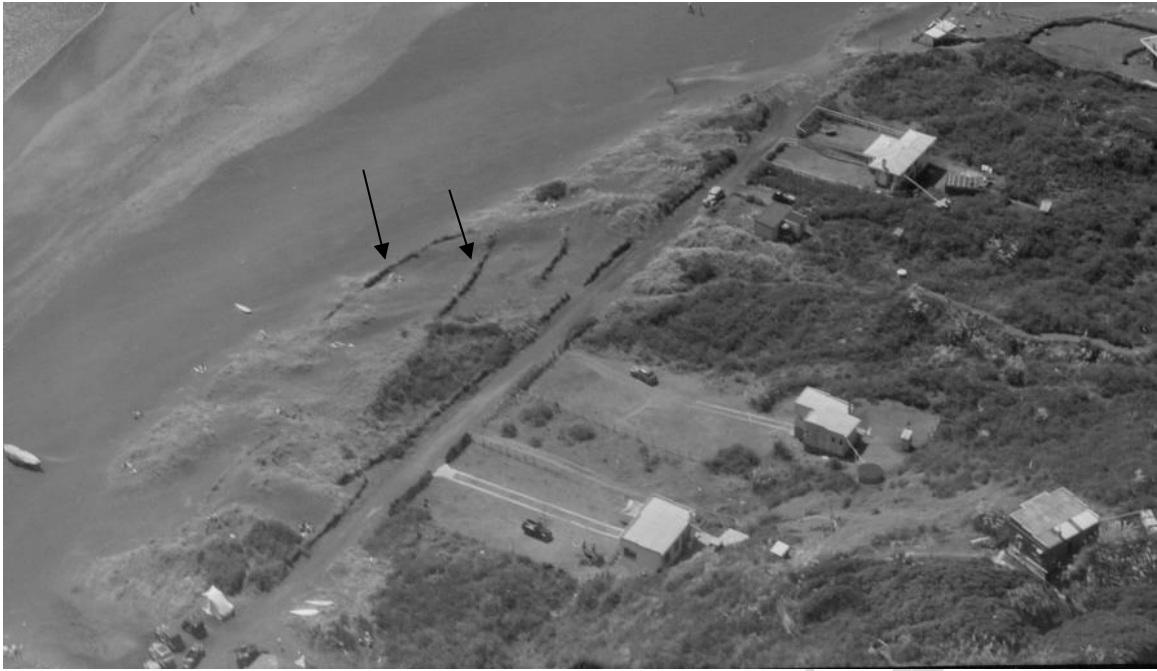
Figure 9: Photograph of Piha taken in January 1951 to the immediate north of the surf club showing brush fences (examples arrowed) erected to control wind erosion. (Whites Aviation photo – from Alexander Turnbull Library).

By the 1950's, photos indicate that human disturbance of vegetation and consequent wind erosion was common with widespread use of brush wind break fences to minimise wind erosion and windblown sand (Figure 9).

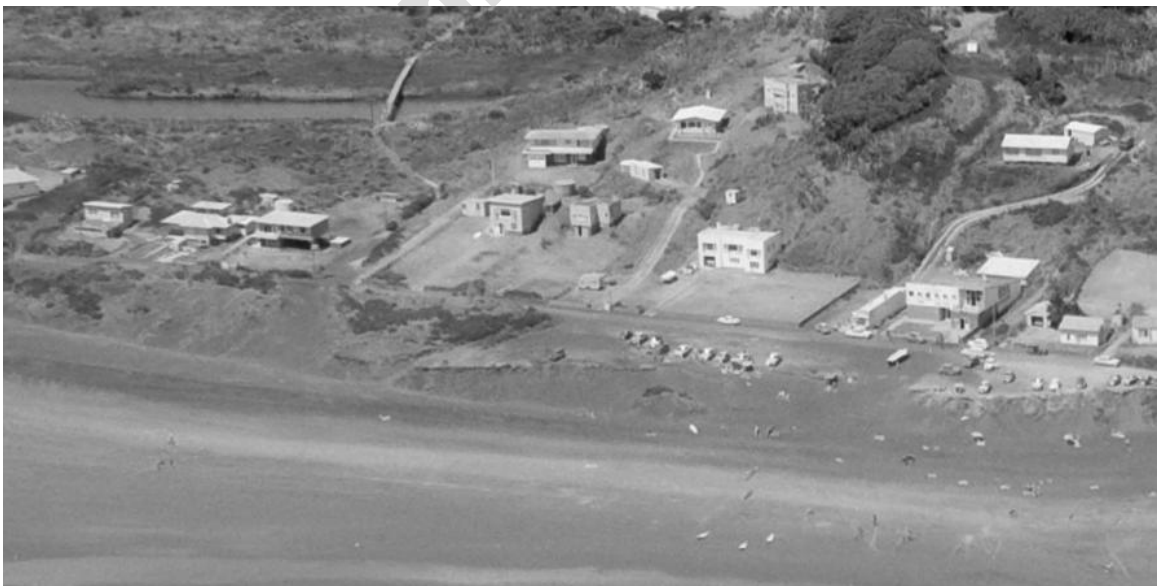
Figure 10: Photograph from 1963 showing area of Piha fronting surf club and areas to the north. Note that dunes fronting the surf club have now been levelled to create a car park and the dune face seaward of this car park is now largely devoid of vegetation. (Whites Aviation photo – from Alexander Turnbull Library).

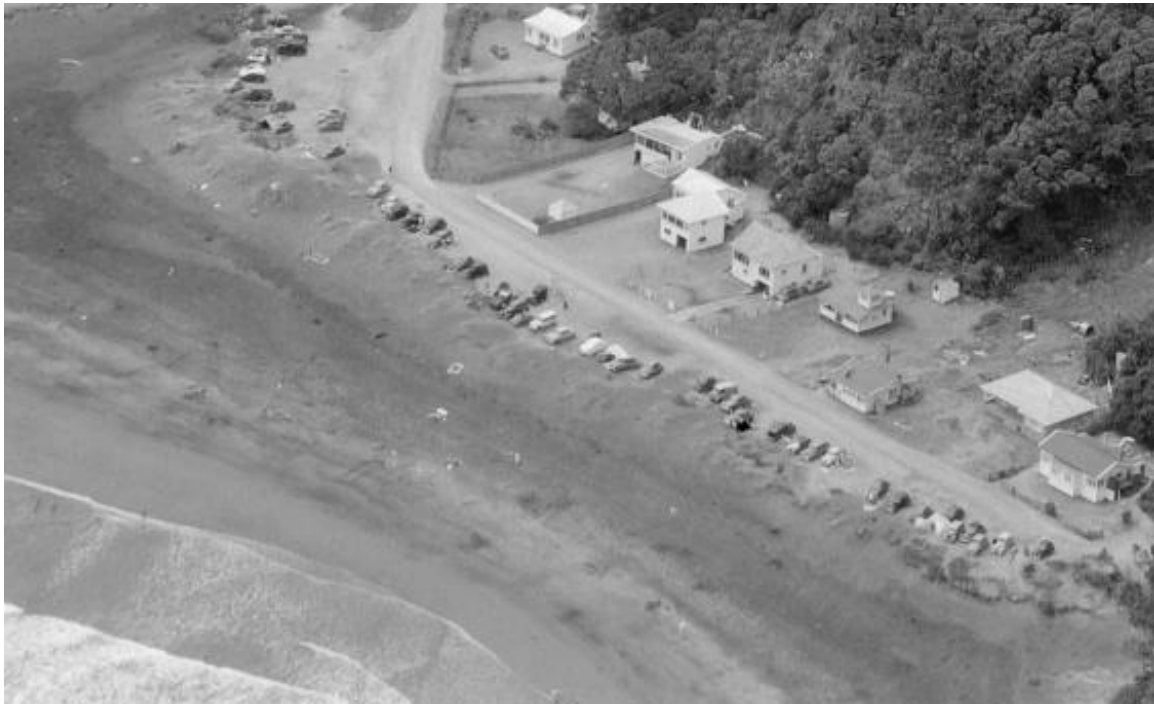
Figure 11: Photograph of southern car park area dating from January 1963.

Parking occurred along the full length during high use periods and access to and from the beach was unmanaged – resulting in extensive disturbance of sand trapping vegetation on the seaward dune face by the early 1960's (Figure 11).

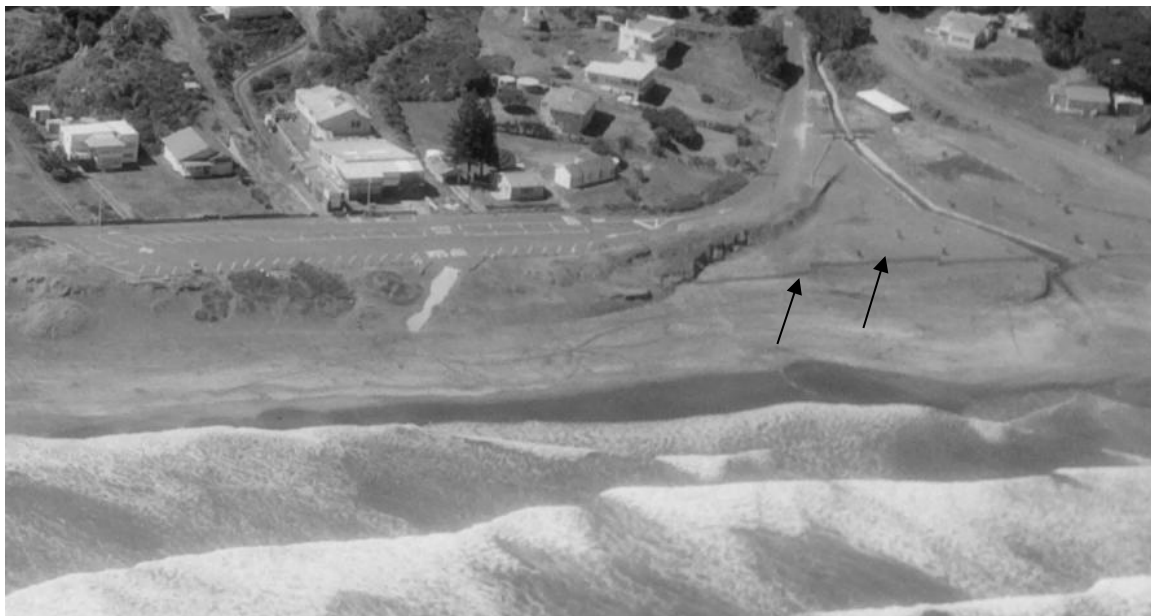
Figure 12: View of surf club car park and Moana Stream entrance area in 1985. Note the concrete stream training works in the Moana Stream and the placement of sand trapping fences (arrowed) to create dunes on the immediate northern side of the former embayment.

In the mid 1980's, the Moana Stream entrance was also significantly modified – including training the stream with a concrete-lined channel (Figure 12), reclamation of the former embayed stream entrance and construction of dunes across the head of the former embayment (these dunes often referred to locally as the “artificial dunes”). The modification of the Moana Stream entrance was controversial and was subsequently deemed unnecessary by the Turner decision.

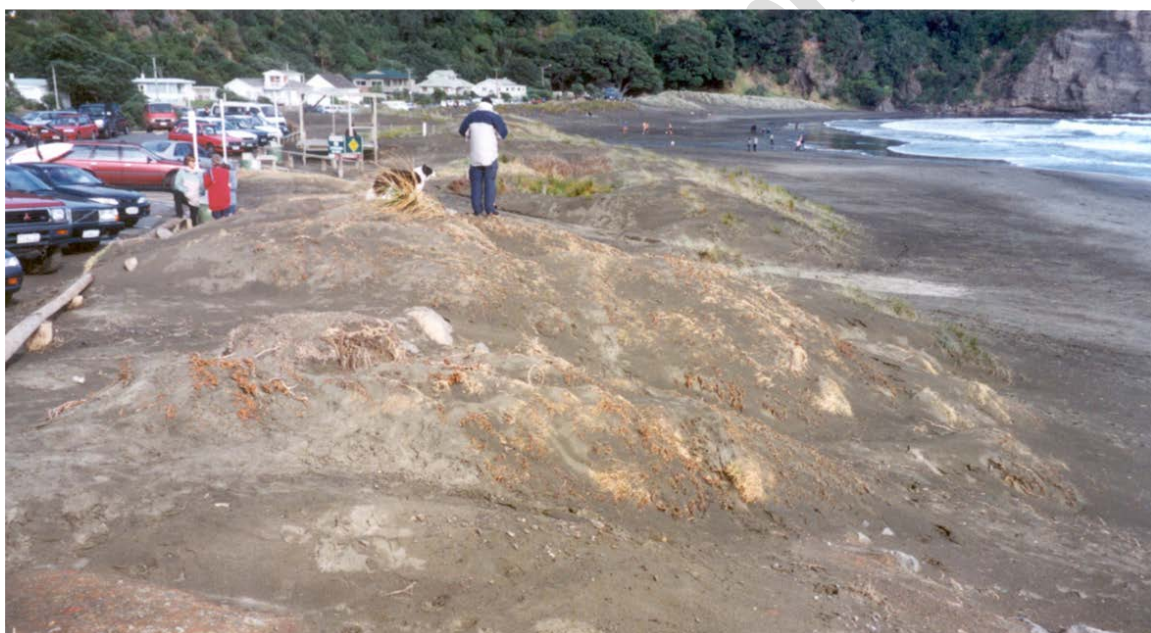
Figure 13: Area in front of surf club (undated but circa 2003) – before commencement of Coastcare dune restoration works. (Photo supplied by Chris Ferkins, Auckland Council).

By the early 2000's, the high use area in front of the surf club was still seriously damaged with exposed clay fill and very little native sand trapping vegetation (Figure 13).

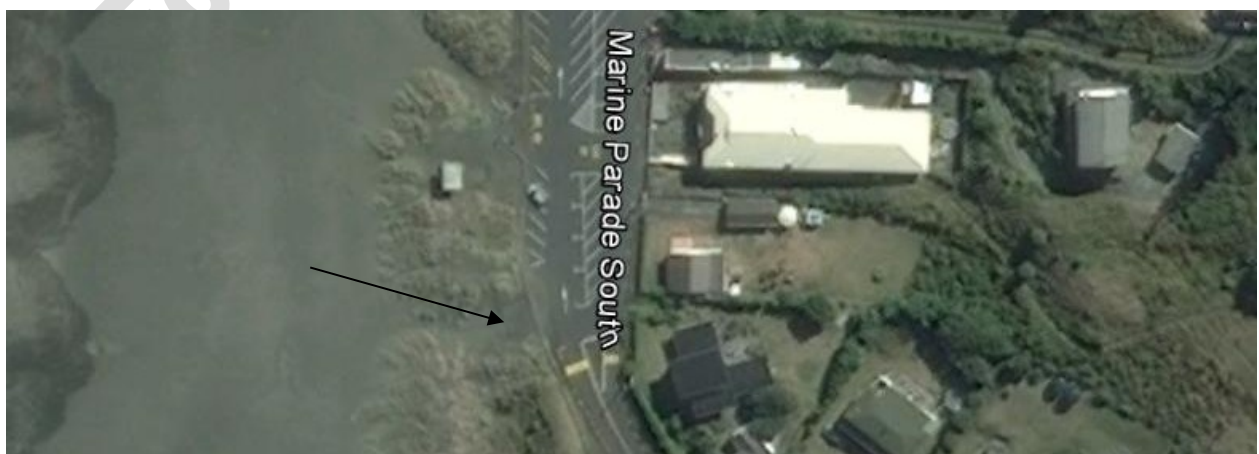
Figure 14: Location of informal accessway (arrowed) at the southern end of the surf club car park. It is recommended that this accessway be formalised and defined.

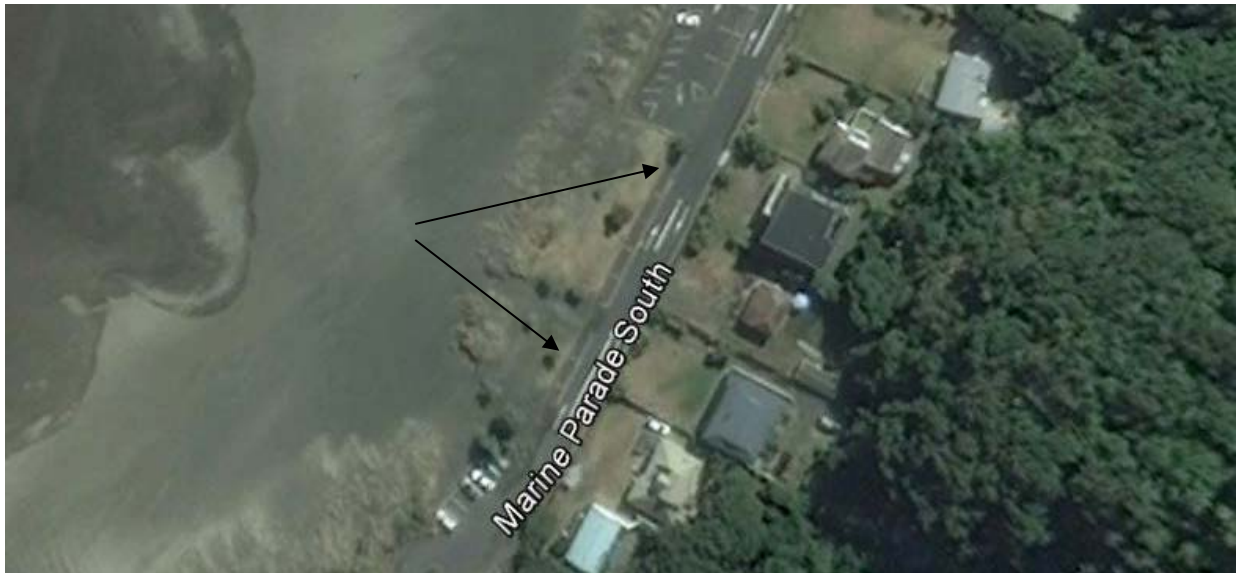
Figure 15: Grassed area behind spinifex zone at western end of the southern car park. This area provides an important grassed elevated viewing area and could readily be levelled to improve suitability for use.

In terms of more immediate action, the existing grassed area at the western end of the southern car park (arrowed in Figure 15) is already extensively used and could be enhanced for use in the near future. For instance, ground levels are presently irregular and could be leveled to improve the area for recreational use. There are also existing small pohutukawa here that will in time provide useful shade – though they may need to be managed (e.g. periodically opened up with careful pruning) to maintain views from landward. This is an important issue to address as otherwise landowners in other nearshore areas will tend to oppose shade trees because of fears of impacts on views. It is important to build trust on this issue as this beach (like many) presently lacks shade trees for beach visitors.

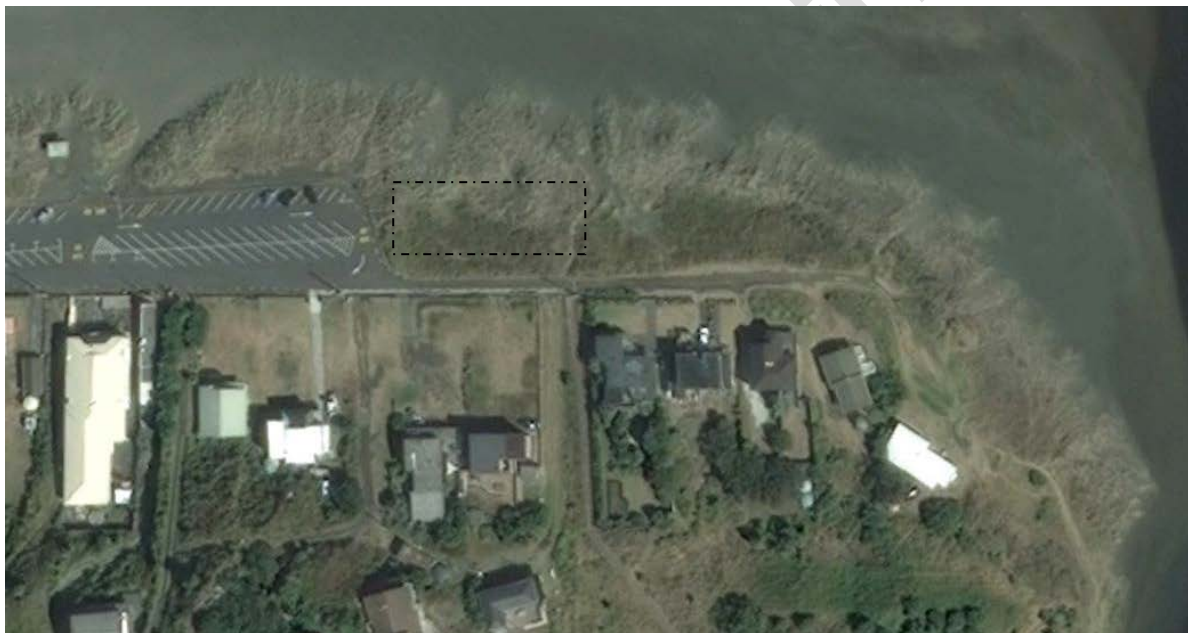
Figure 16: dashed line outlines backdune area to the immediate north of the surf club car park within which a grassed viewing area could potentially be established – subject to appropriate design and consultation.

There are also other local areas, one of which could be appropriate to develop as a raised grassed viewing area given the high human use in this area of Piha. For instance, there are elevated backdune areas to the immediate north of the surf club car park part of which could be used to establish an elevated grassed areas, while still maintaining a wide spinifex zone (at least 30–35 m) to seaward (Figure 16). An advantage of this area is that it is not only immediately adjacent to the surf club car park but also borders the beach access from the Domain
